CONTINUOUSLY REINFORCED CONCRETE PAVEMENT
IN CALIFORNIA
AFTER EIGHT YEARS SERVICE

Bailey Tremper
Supervising Materials and Research Engineer
California Division of Highways

For Presentation at the
37th Annual Meeting - Highway Research Board
Washington, D.C.
January, 1958

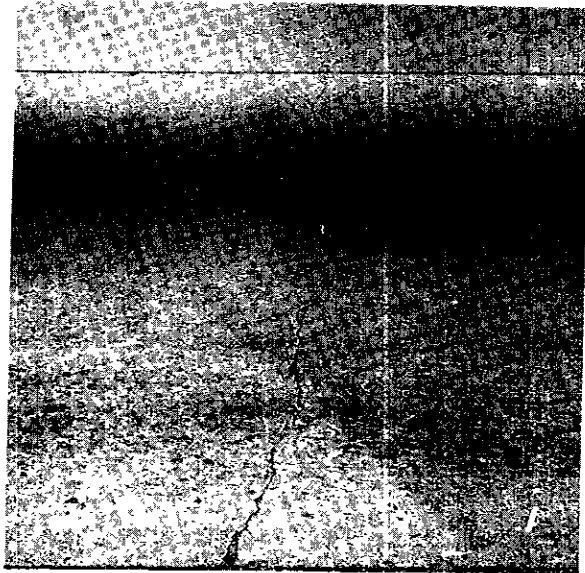
The average uncracked slab length in the outer lane of Section 2 of the reinforced pavement was 4.2 feet in 1950. By 1957 the average length had decreased to 3.2 feet. All of

the cracks appear to be tight with little or no spalling. None shows evidence of pumping. Figure 1 is a view of one of the most prominent cracks in the reinforced section. Figure 2 is a view of a typical weakened-plane joint in the section adjacent to the reinforced section. Figure 3 shows a random crack in the non-reinforced pavement.

A prominent crack in the continuously reinforced pavement.

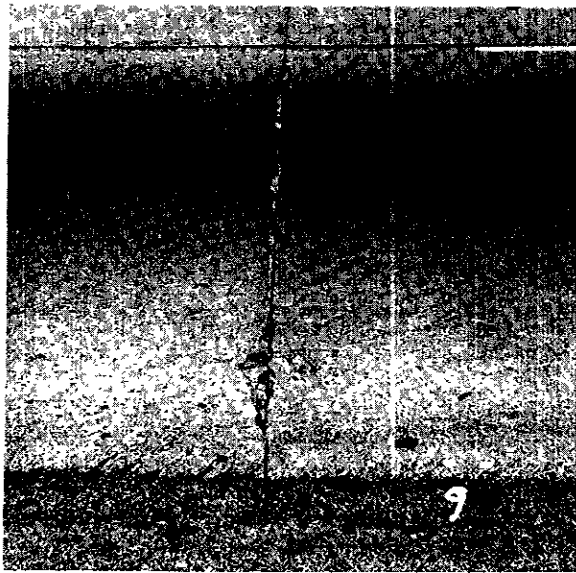
Figure 2

A typical joint in the non-reinforced pavement.

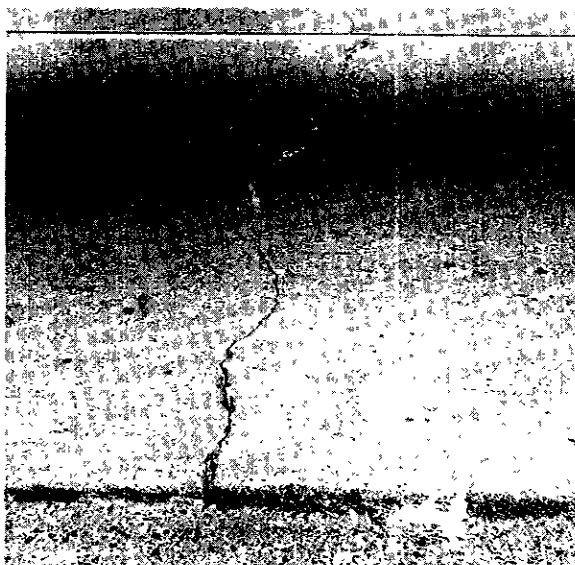
Figure 3

One of a very few random cracks in the non-reinforced pavement.

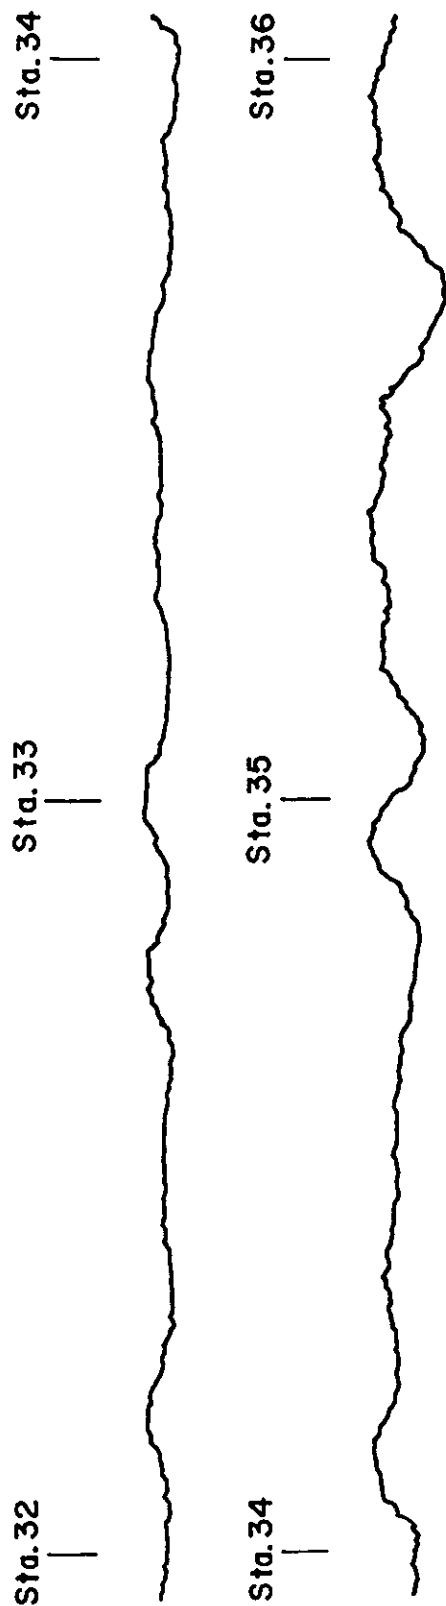
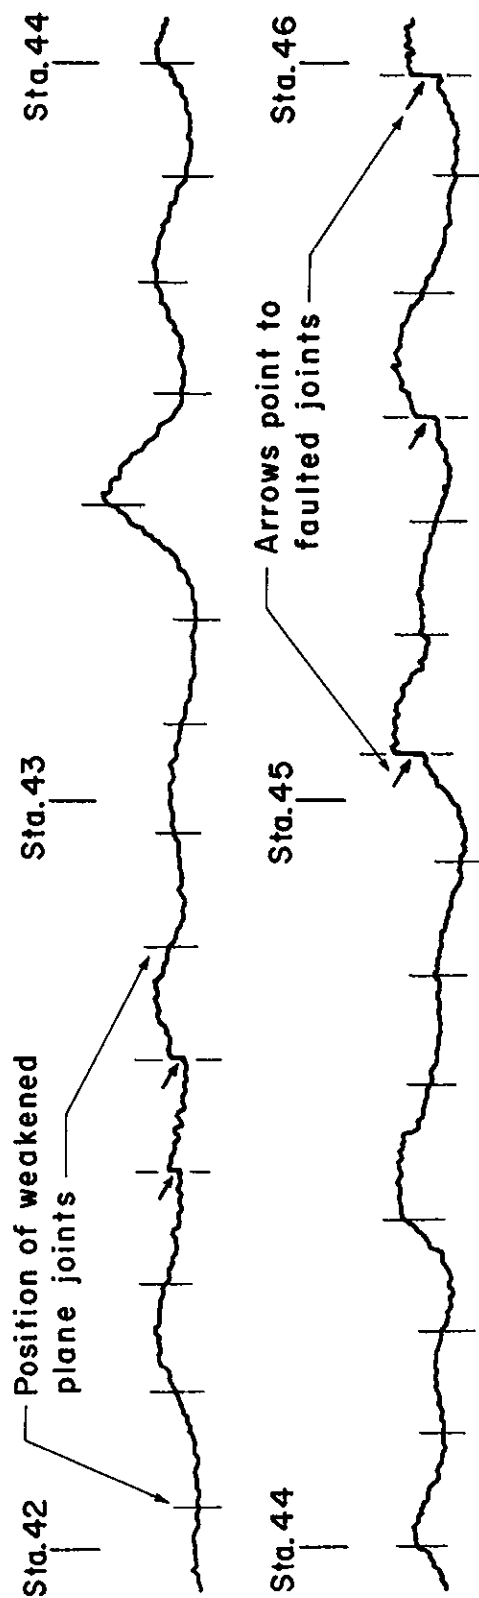
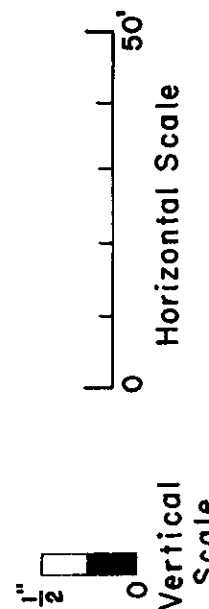
Figure 4

Short sections of profilograms obtained during the afternoon of June 25, 1957, are shown in Figure 4. The sections shown in this figure include those that were shown as Figure 20 in Stanton's report. They are fairly representative of the entire reinforced and non-reinforced sections other than those portions that have been affected by settlement at cross culverts. It will be noted that a moderate amount of faulting is indicated at a few of the joints in the non-reinforced section.

Faulting less than 0.1 inch cannot be measured accurately from profilograms and only those of greater magnitude are considered in the following discussion. Such faulting has developed only in the non-reinforced section lying east of the reinforced section. In this portion, faulting of 0.10 inch or more has developed in the outer (driving) lane at 17 percent of the joints. The average faulting at these joints is 0.14 inch. This faulting and random cracks in 6 percent of the slabs are the only evidence of distress in the non-reinforced pavement.

Profilograms of outer (driving) lane
taken afternoon of June 25, 1957,
temperature 103°. Fairfield Test Section.
